1st Choice Property Inspectors, Inc.
12351 Huntoon Rd.
Concord, OH 44077
Prepared For My Happy Home Buyer

Home Inspection Report

1234 School House Road
Yourtown, US 12345

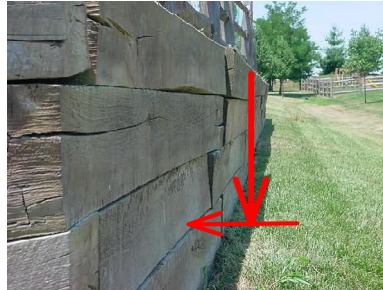
Balcony: Concrete
Porch: Concrete
Vegetation: Shrubs with some weeds
Retaining Walls: Railroad ties The wall is showing signs of movement, but appears to be stable at this time. A qualified contractor is recommended to evaluate and estimate repairs to maintain the wall.

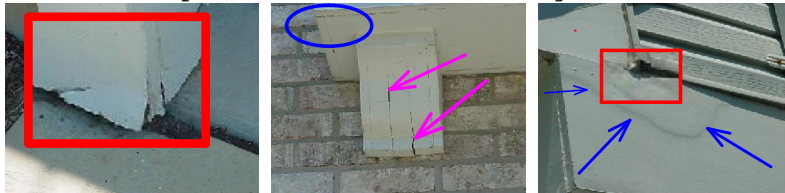
- 2. Acceptable **Type:** Vinyl siding
- 3. Defective **Trim:** Composite material **Note:** Damaged wood areas should be checked while doing the repair and replaced if wood rot is present.

1. Water damage to trim wood at either side of garage door from moisture wicking into the finished particle board. The surface is starting to delaminate. Recommend repair/replacement of the trim boards and silicone seal wood that is in contact with concrete to prevent wicking.
2. The wood window boxes have water damage and will require repair/replacement. The wood has started to separate at the supports and at the corners of the window boxes.
3. The trim board at the southwest corner of the porch has water damage due to water penetration and will require repair/replacement of the wood. The trim board extends out creating a ledge allowing water to collect on the top edge of the board and cause the wood to rot.

Recommend estimate/repairs by a qualified contractor.

Cost to Replace Low: \$ 500 - High: \$ 1000
